REPORT NO.
UCB/EERC-97/13
DECEMBER 1997
59A131

FATIGUE LIFE EVALUATION OF CHANGEABLE MESSAGE SIGN STRUCTURES

VOLUME 2: RETROFITTED SPECIMENS

Report to the California Department of Transportation
for Research under Contract RTA-59A131

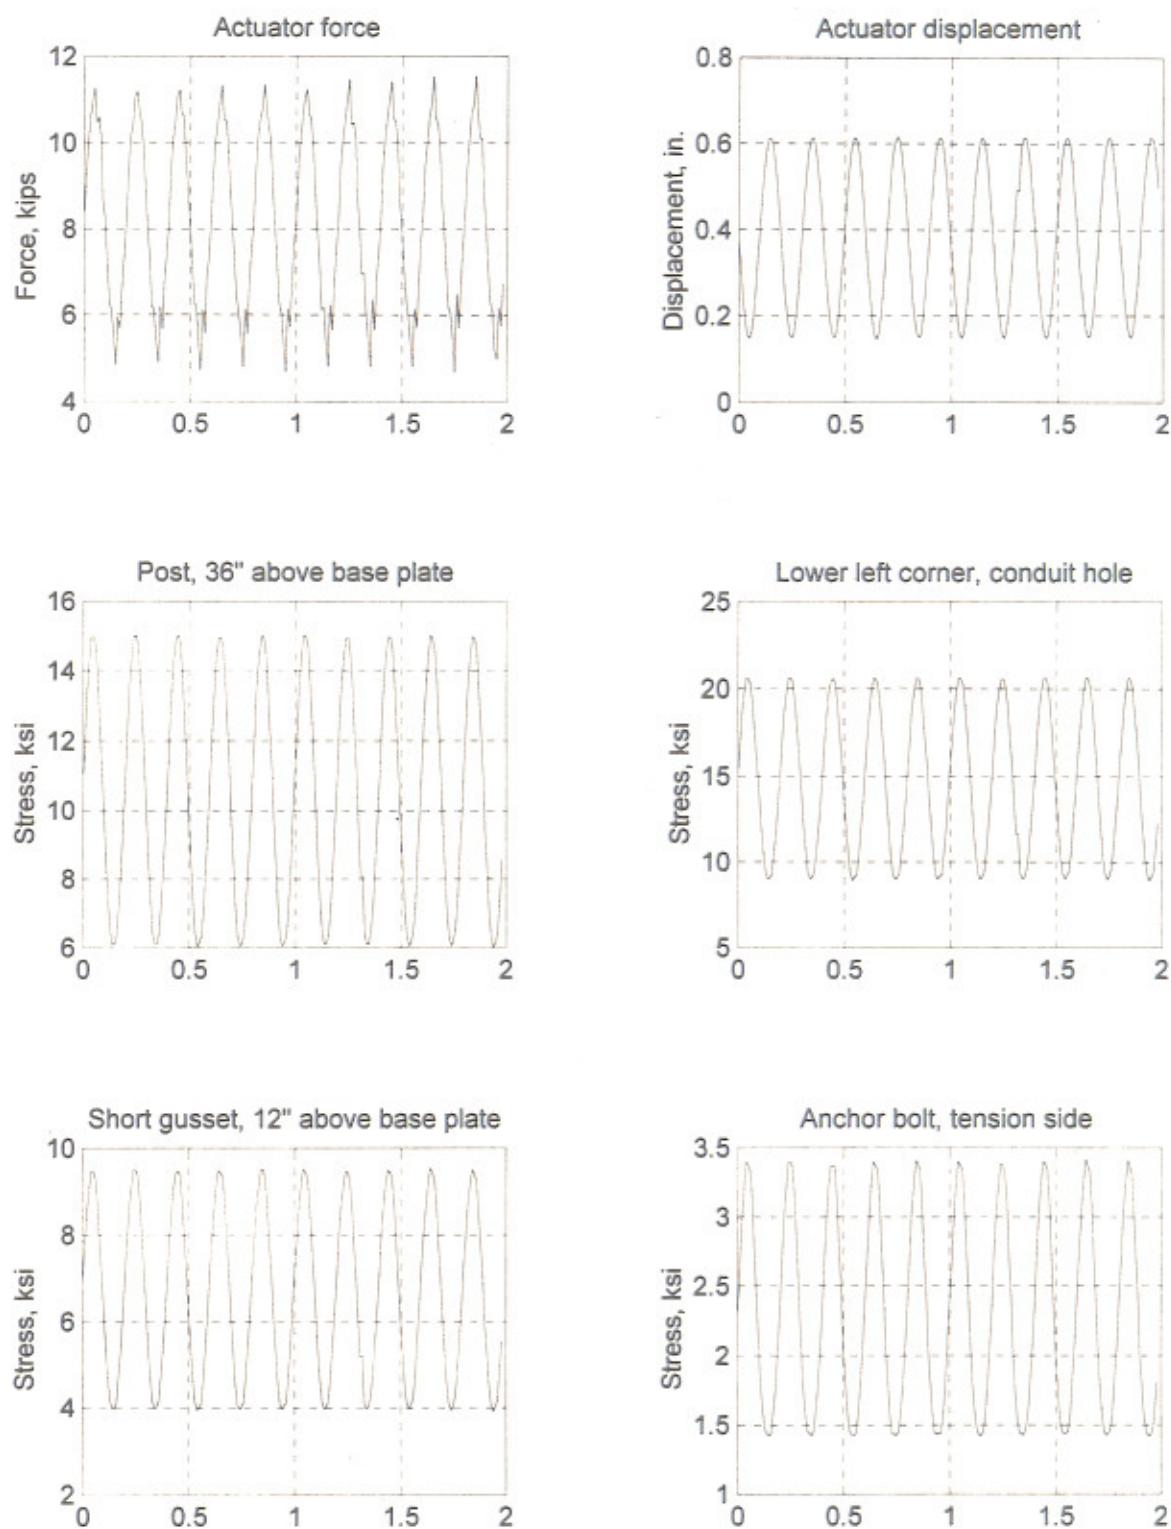
Figure 4.8: Typical response histories for Specimen GR1

Typical test data is shown in Figure 4.8. The data in these plots were collected at a cycle count of 10,000 cycles and are representative of the response of Specimen GR1 prior to substantial cracking. The stresses were obtained by multiplying the strain gage values by Young's modulus for steel, assumed to be 30,000 ksi (207 GPa). The plots show the response histories of the actuator force and displacement, the post stresses 36 in. (914 mm) above the base plate (sg2), the stresses at the lower left corner of the conduit hole (sg39), the stresses at the gusset plate CD (sg43), and the stresses at the anchor bolts in the tension side (sg52).

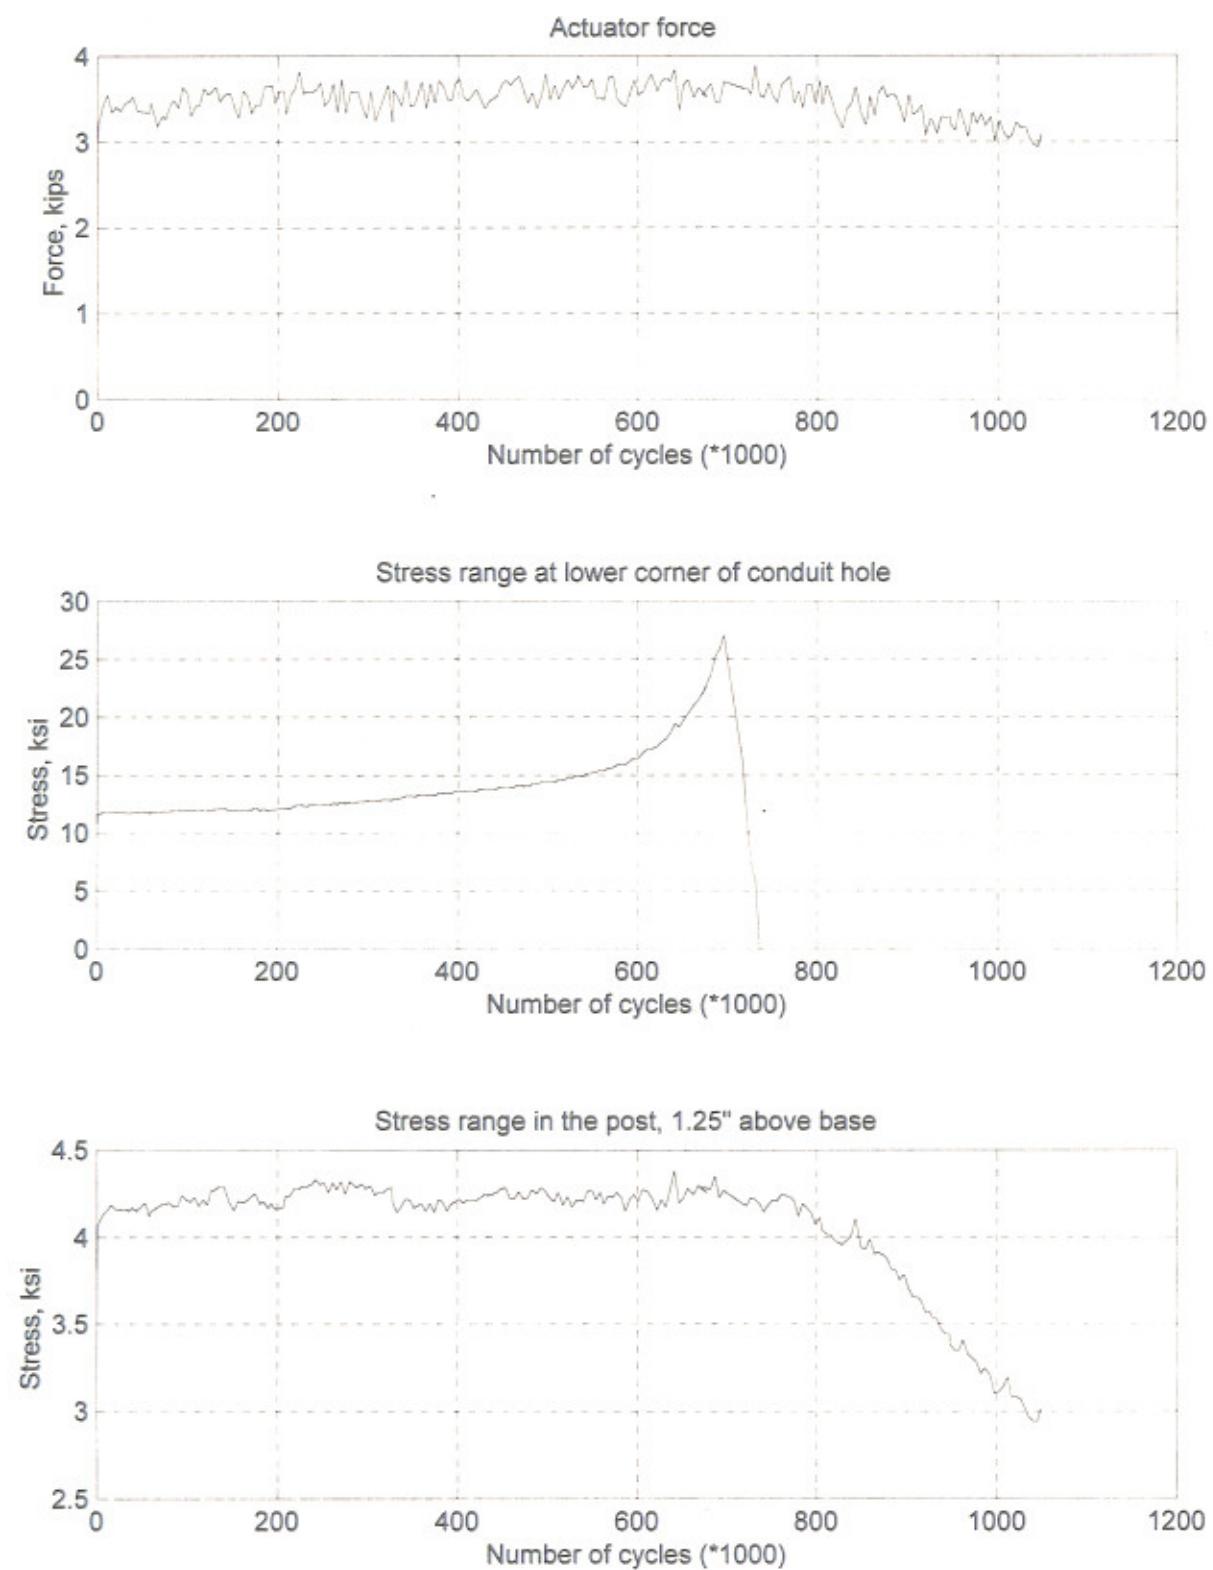
Figure 4.9: Response maxima for Specimen GRI

The minimum and maximum responses were computed for each data channel and for all 212 tests. Figure 4.9 shows the response maxima of the actuator force history, the stress range at the lower corner of the conduit hole (sg 39), and the stress range in the post at 1.25 in. (32 mm) above the base plate on the tension side (sg33). The actuator force is relatively constant up to approximately 800,000 cycles, and starts to decrease noticeably thereafter. A similar trend is noted for the post stresses 1.25 in. (32 mm) above the base plate. The post stresses at the lower end of the conduit hole increase substantially after approximately 300,000 cycles due to stress redistribution in the post following cracking adjacent to the conduit hole. After approximately 700,000 cycles, cracks propagated to the gage, and the strain readings dropped to zero.

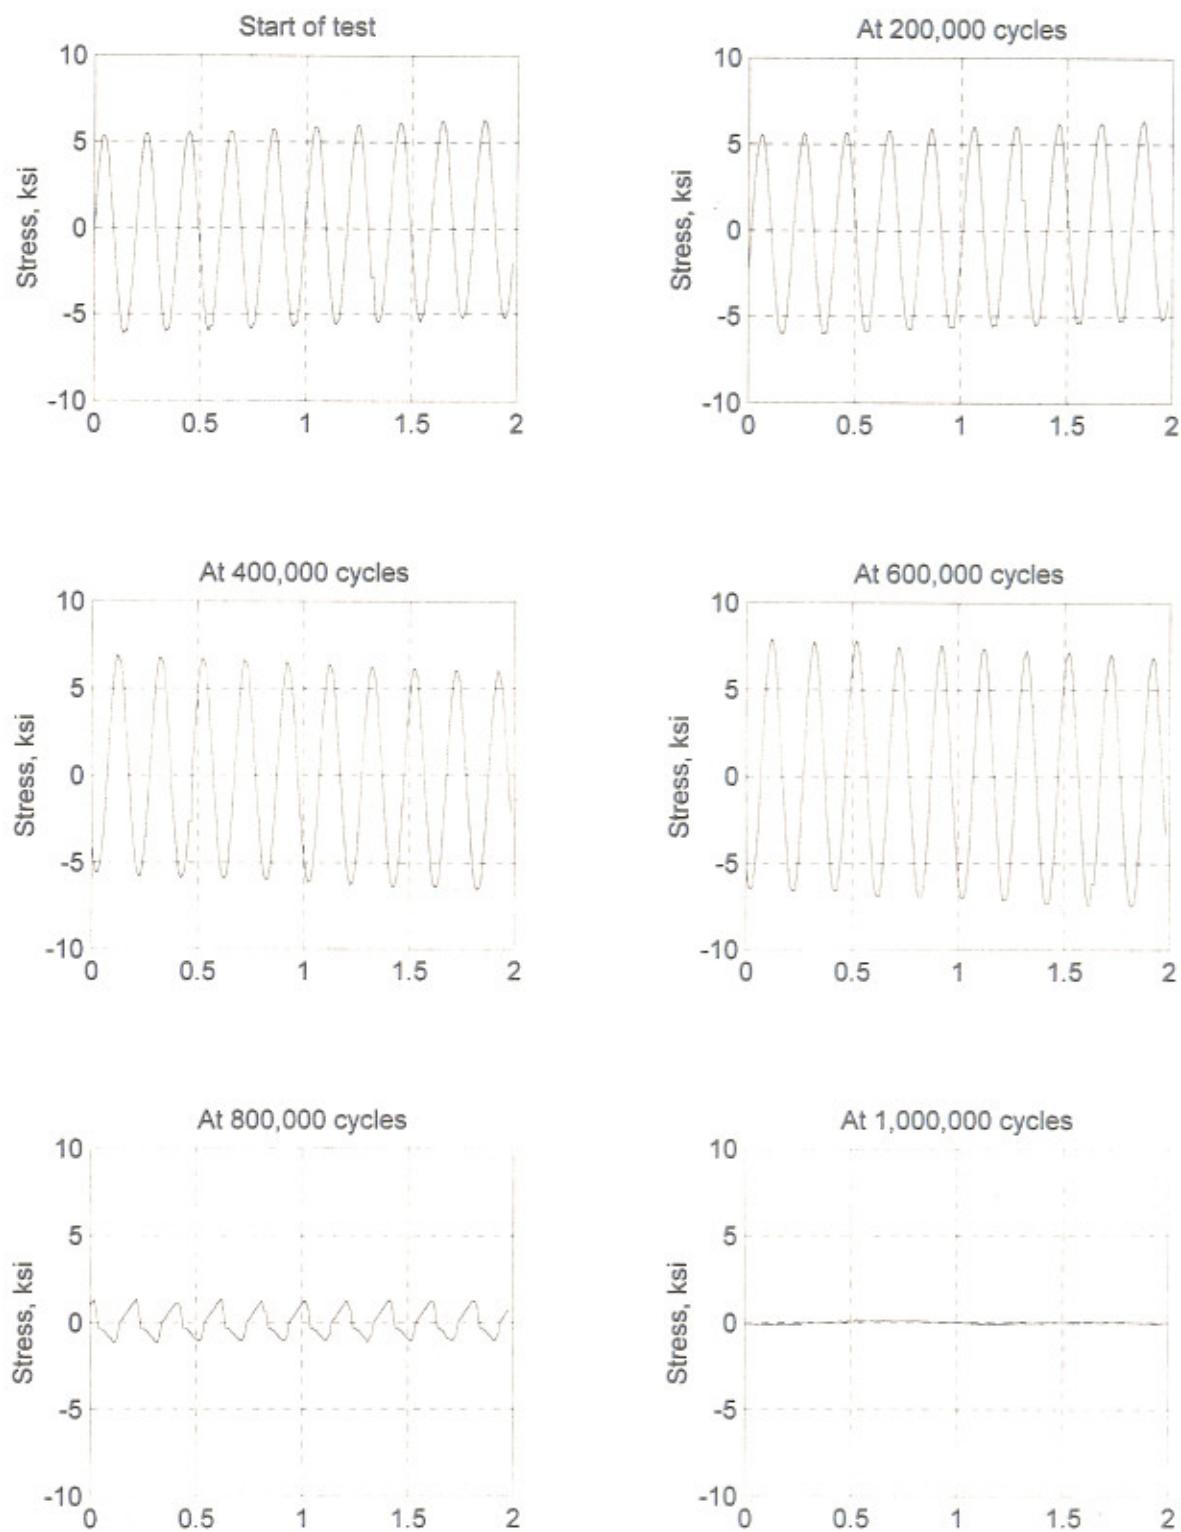
Figure 4.10: Response history (mean value removed) at the bottom left corner of conduit hole for Specimen GR1

Figure 4.10 shows the average stress (strain) response, near the lower corner of the conduit hole, at 200,000 cycle increments of loading. The data shown was corrected to remove the drift in the transducer response history. Up to 600,000 cycles, the data is essentially symmetric and sinusoidal. At 800,000 cycles, the stress response has lost both its symmetry and its sinusoidal shape, and the stresses are significantly smaller indicating the presence of adjacent cracks. At 1,000,000 cycles, the stresses are negligible due to cracking at the sensor location.

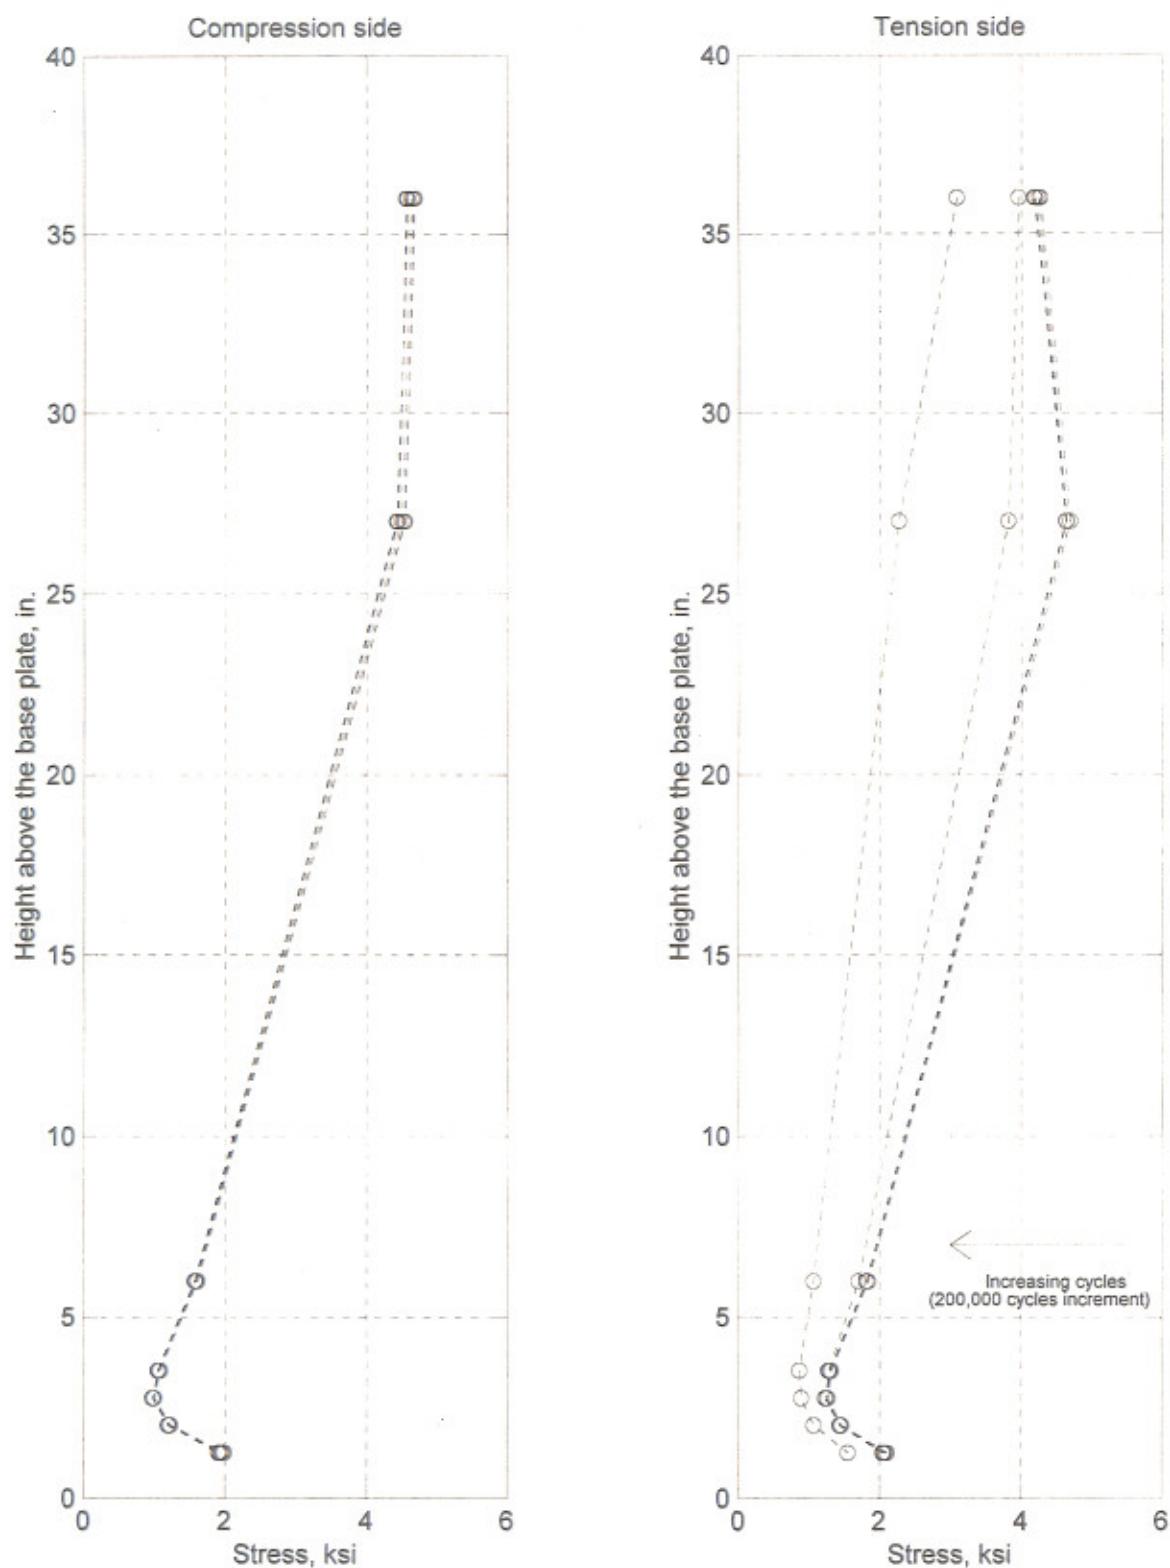
Figure 4.11: Stress distribution (mean value removed) along the post for Specimen GR1

Figure 4.11 shows the stress profile on the tension and compression faces of the post. The stresses are plotted for every 200,000 cycles. The stress distribution on the compression side does not change with the number of test cycles. However, on the tension side, the stress distribution varies with the number of cycles. Up to 600,000 cycles, the stress distribution is stable, but varies thereafter as the cracks around the conduit hole grow substantially. The highest stresses in the tension side occur 27 in. (686 mm) above the base and above the gusset plate. Below this height, the stresses in the post are dramatically reduced due to

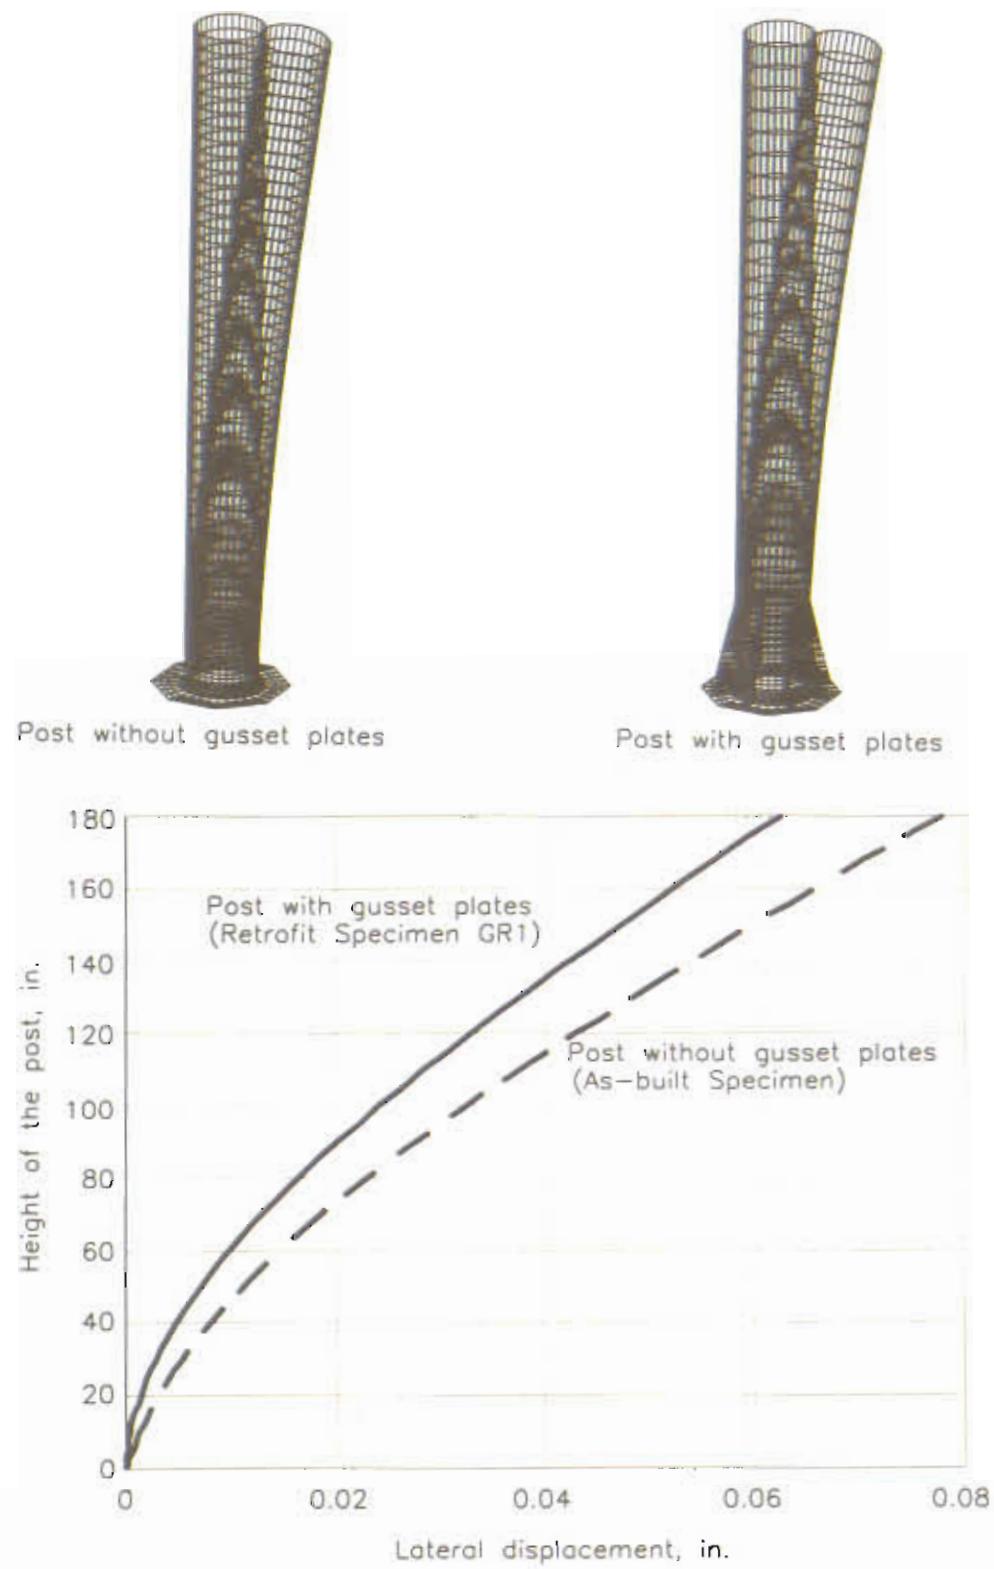
Figure 4.13: Deformed configuration due to a unit load applied at the top of Specimen GR1

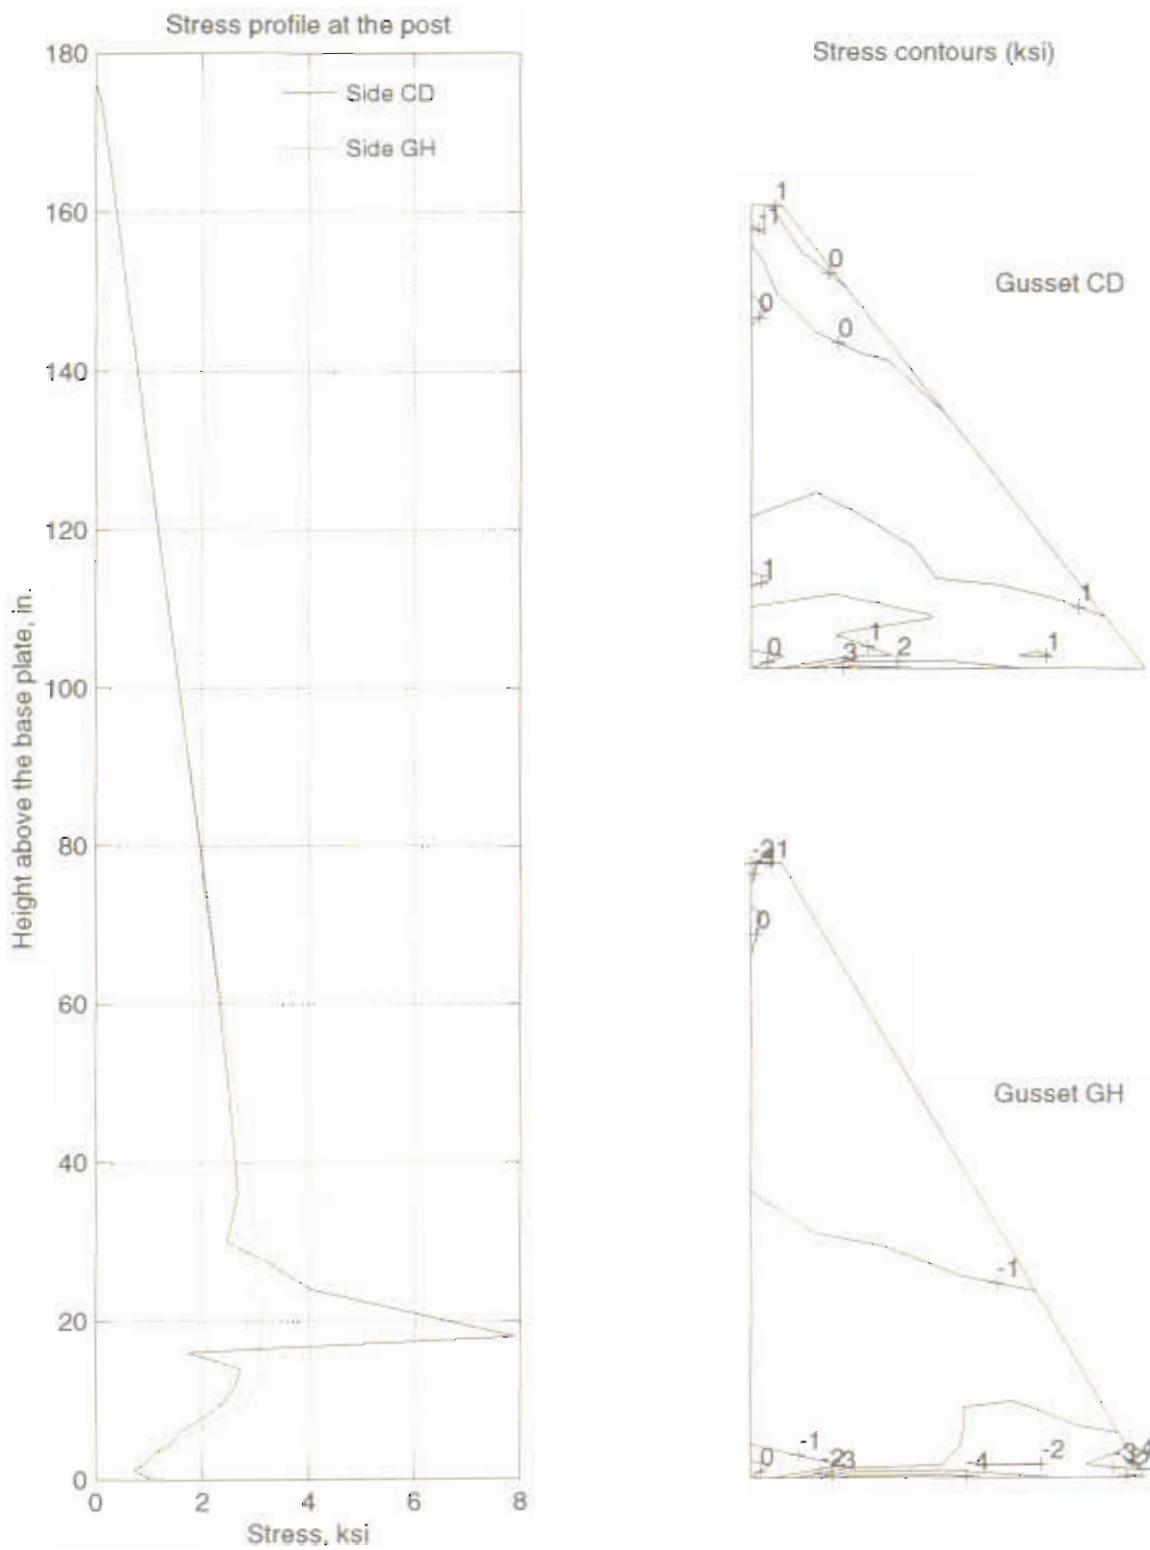
Figure 4.14: Computed stresses for Specimen GR1

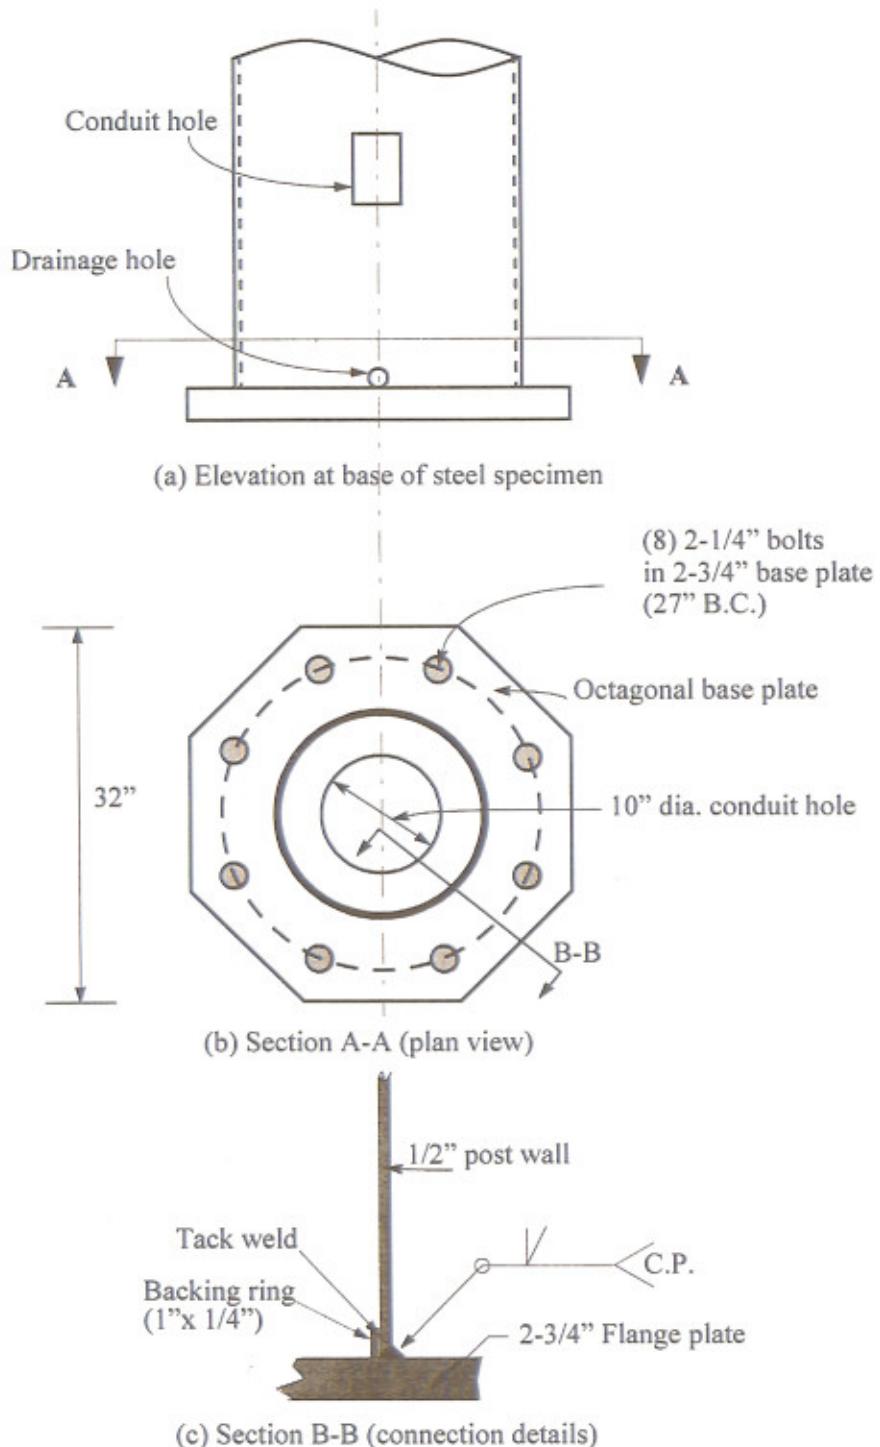
Figure 5.1: Connection details for the steel post of Specimen CIP1

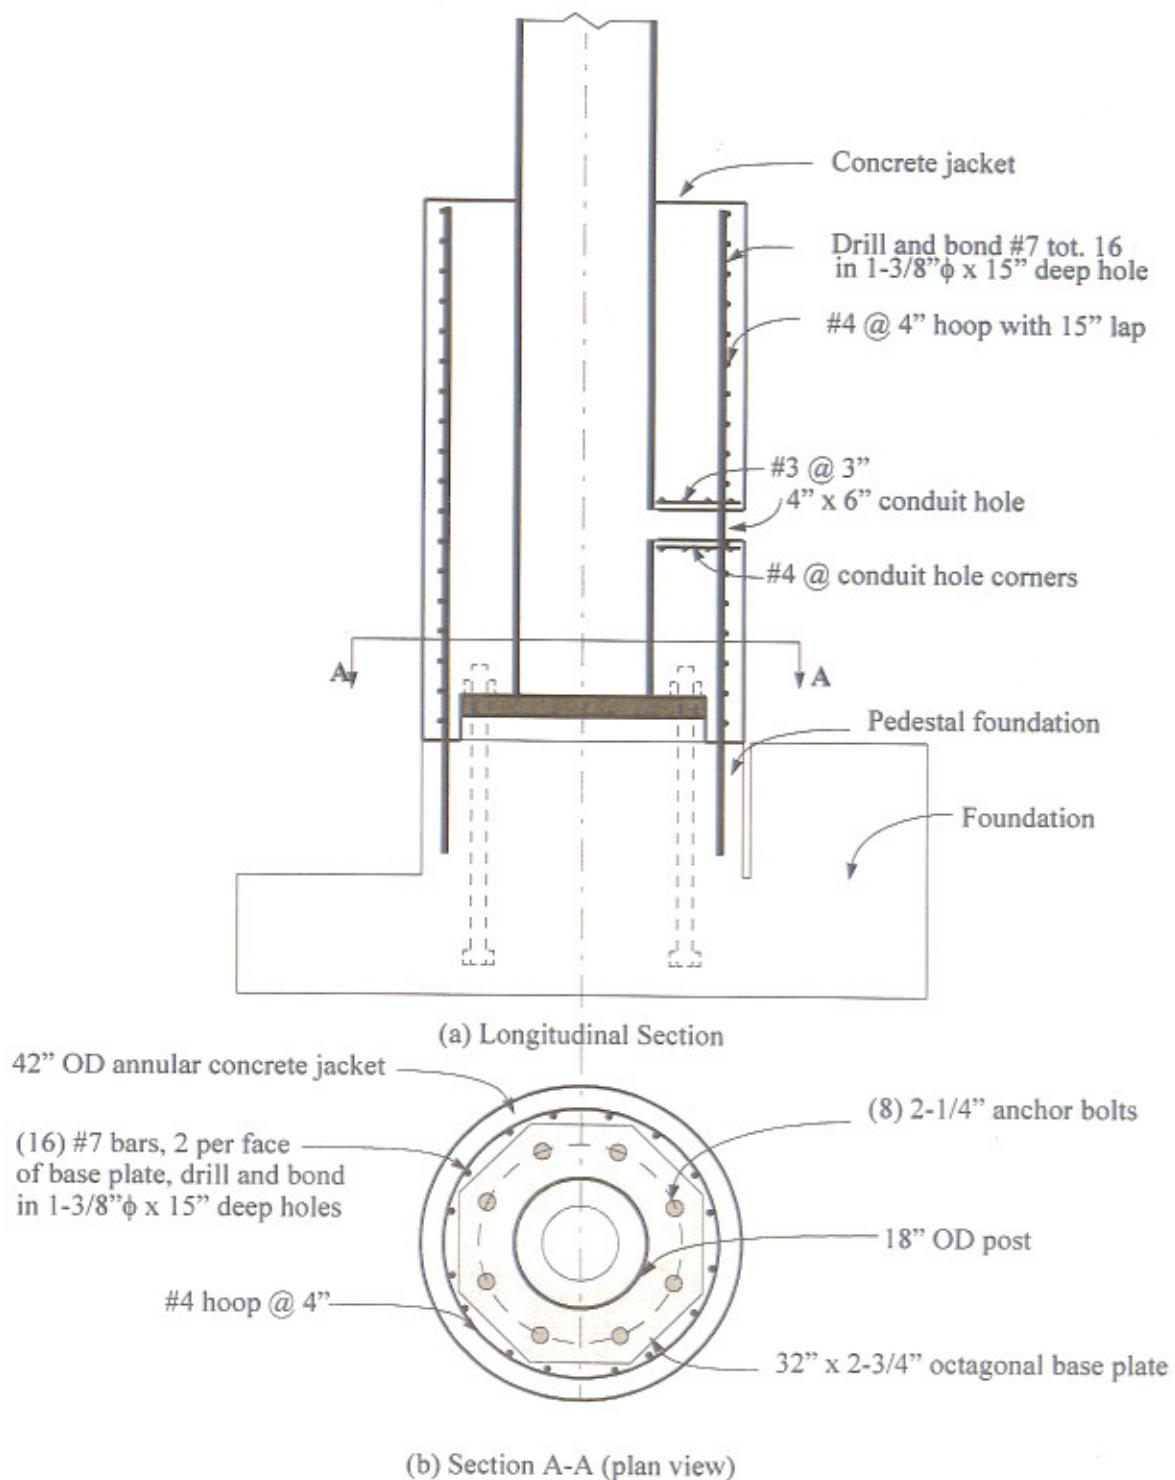
Figure 5.2: Retrofit details for Specimen CIP1

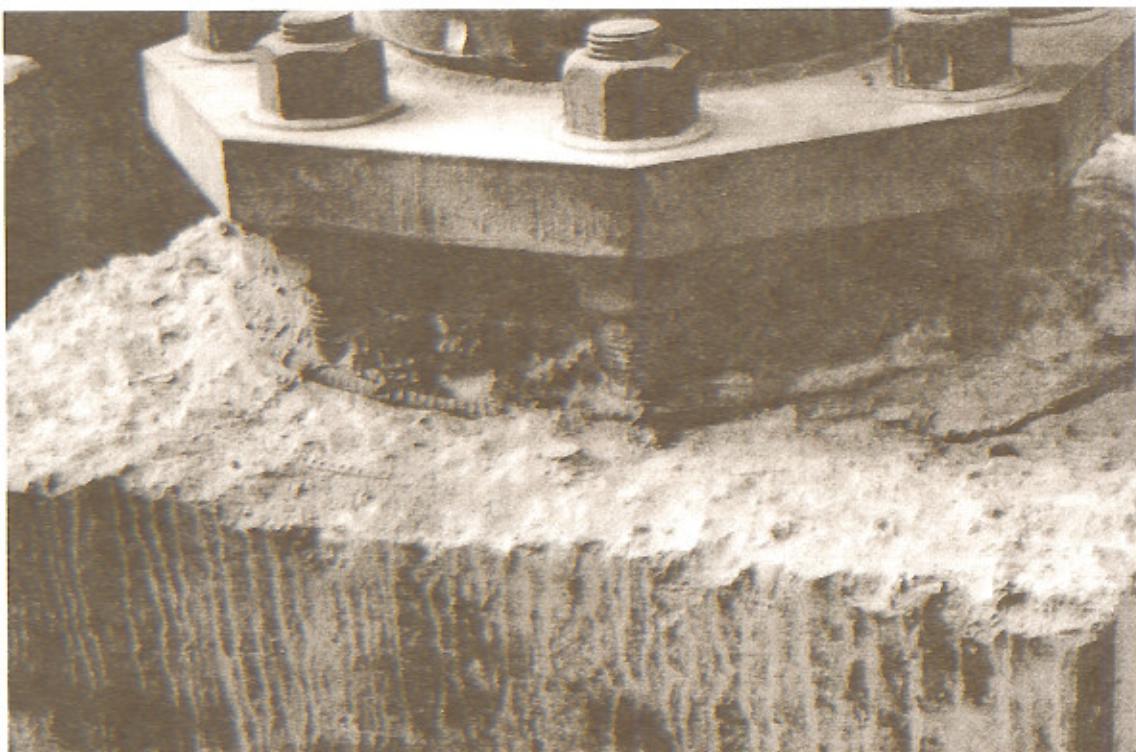
Figure 5.3: Removing the cover concrete and exposing top reinforcement

The retrofit work included: 1) removing the cover concrete to expose the foundation top

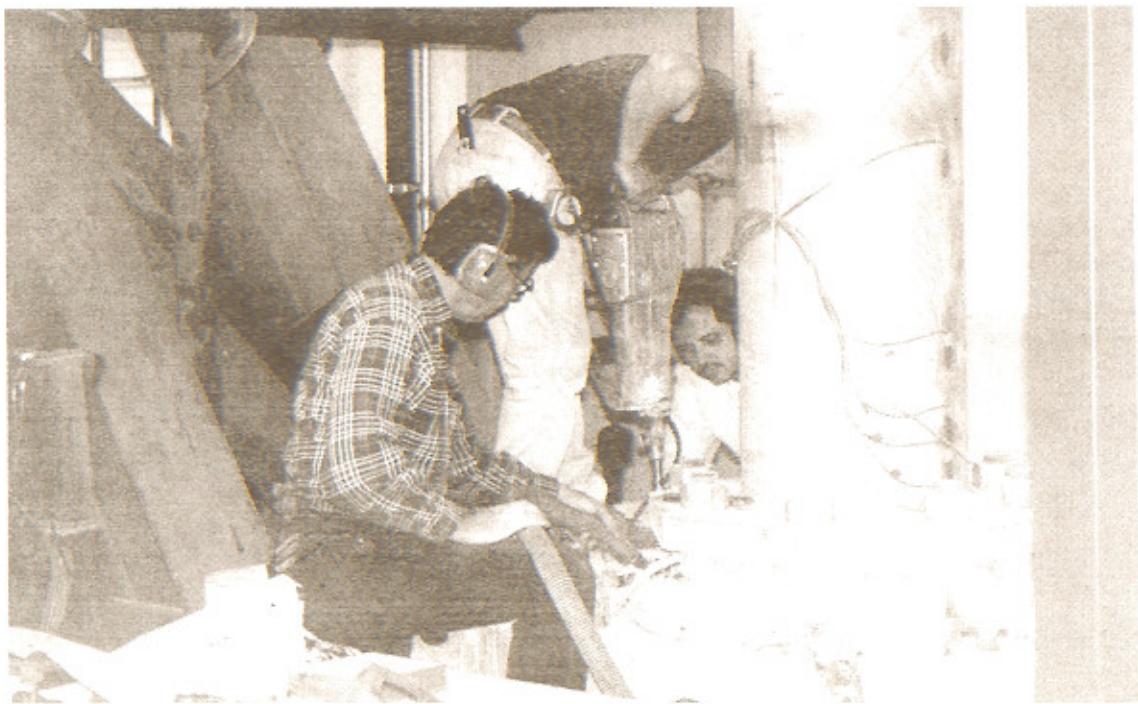
Figure 5.4: Drilling the existing foundation

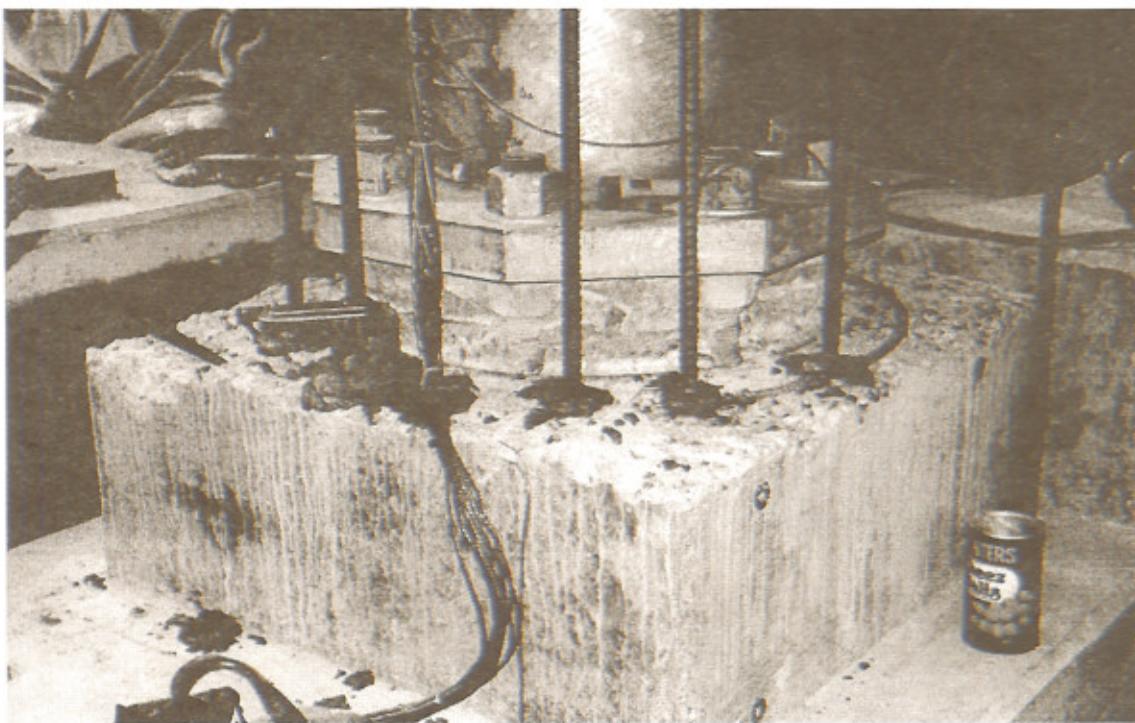
Figure 5.5: Grouting the longitudinal reinforcement

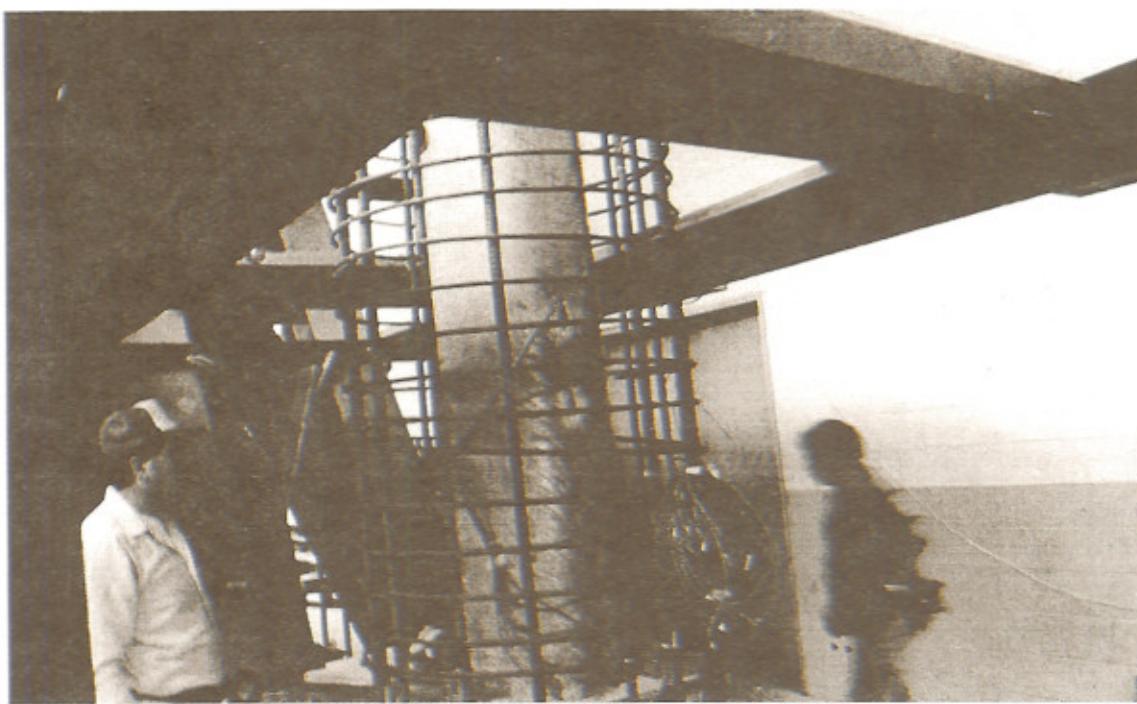
Figure 5.6: Placing the transverse hoops

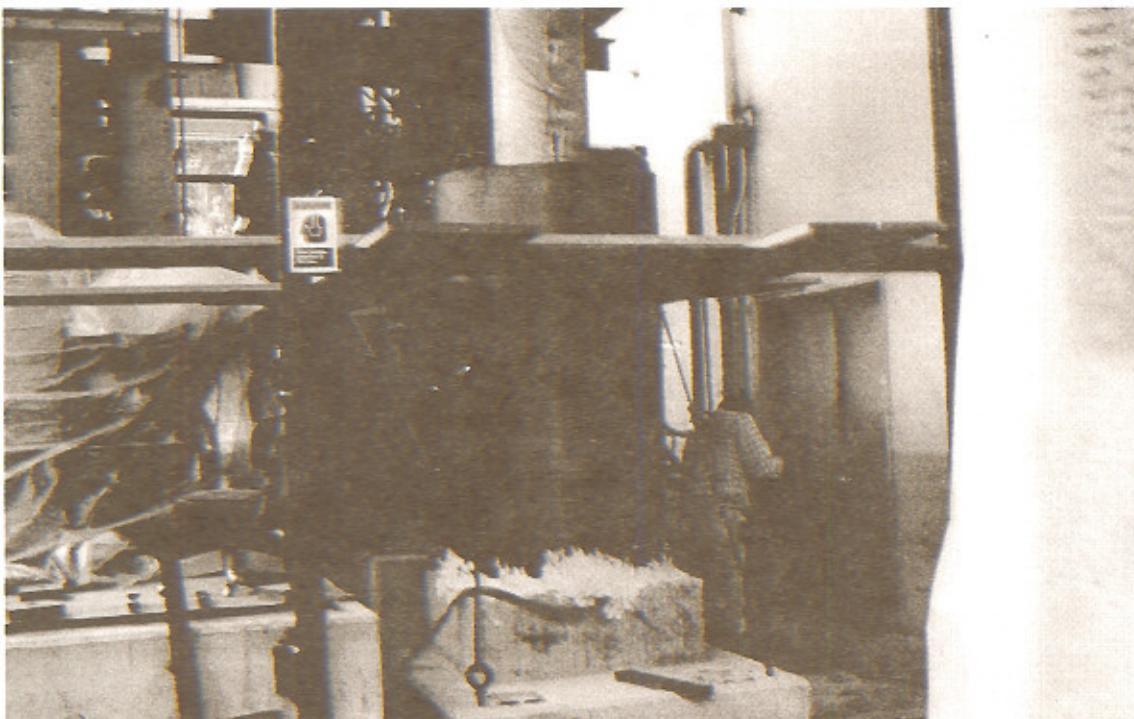
Figure 5.7: Placing the steel formwork

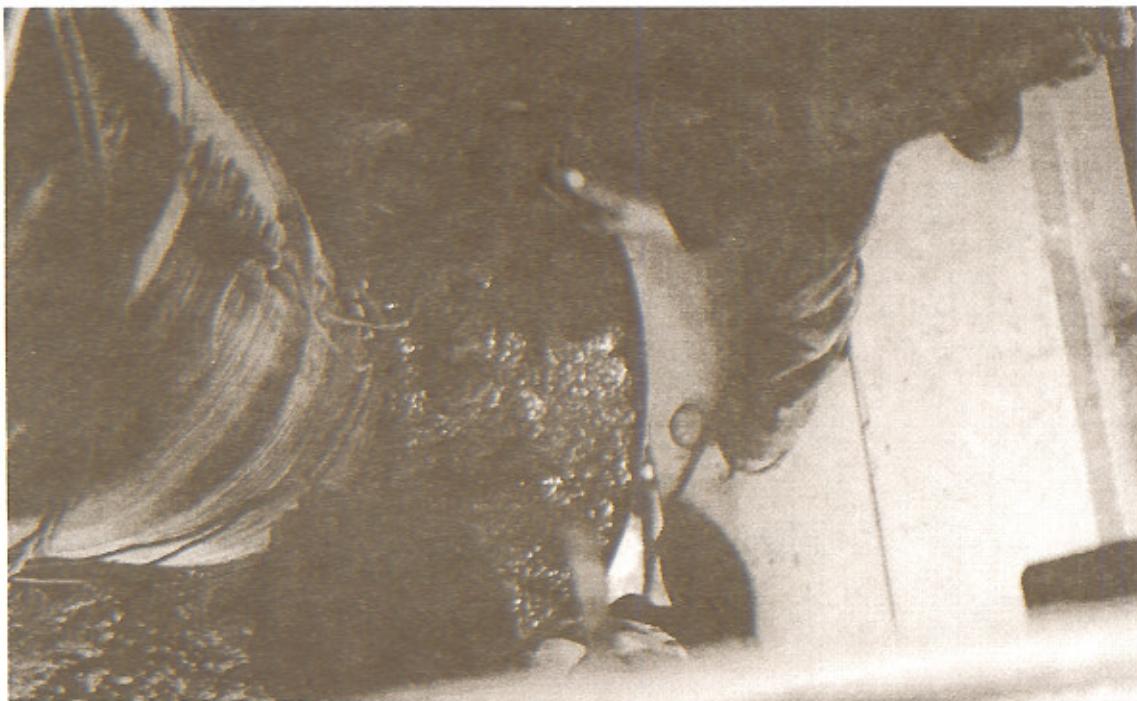
Figure 5.8: Casting the concrete jacket

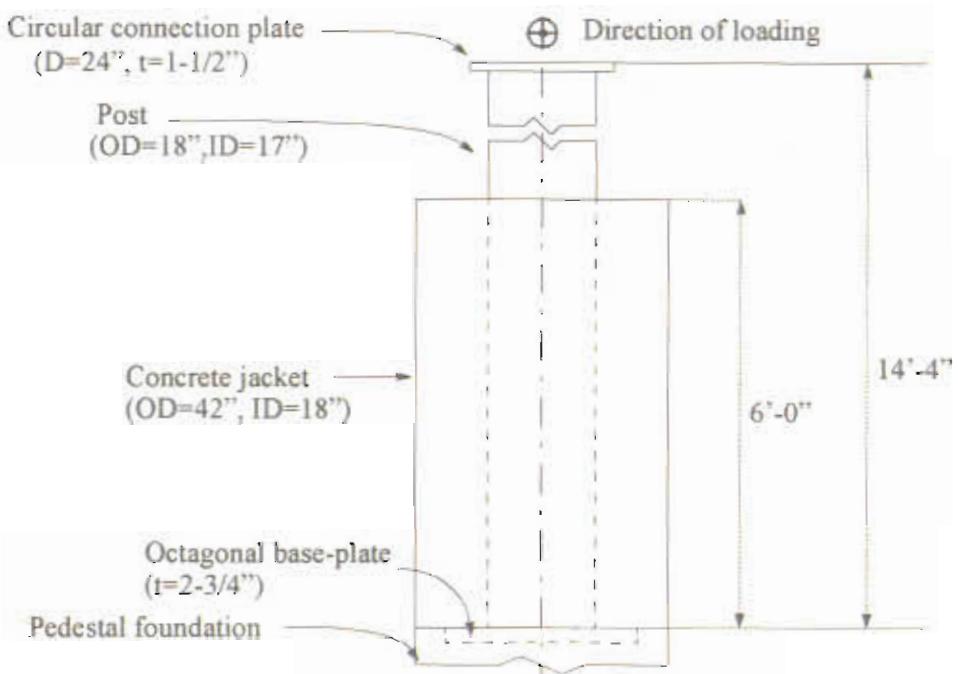
Figure 5.9: Test setup for Specimen CIP1

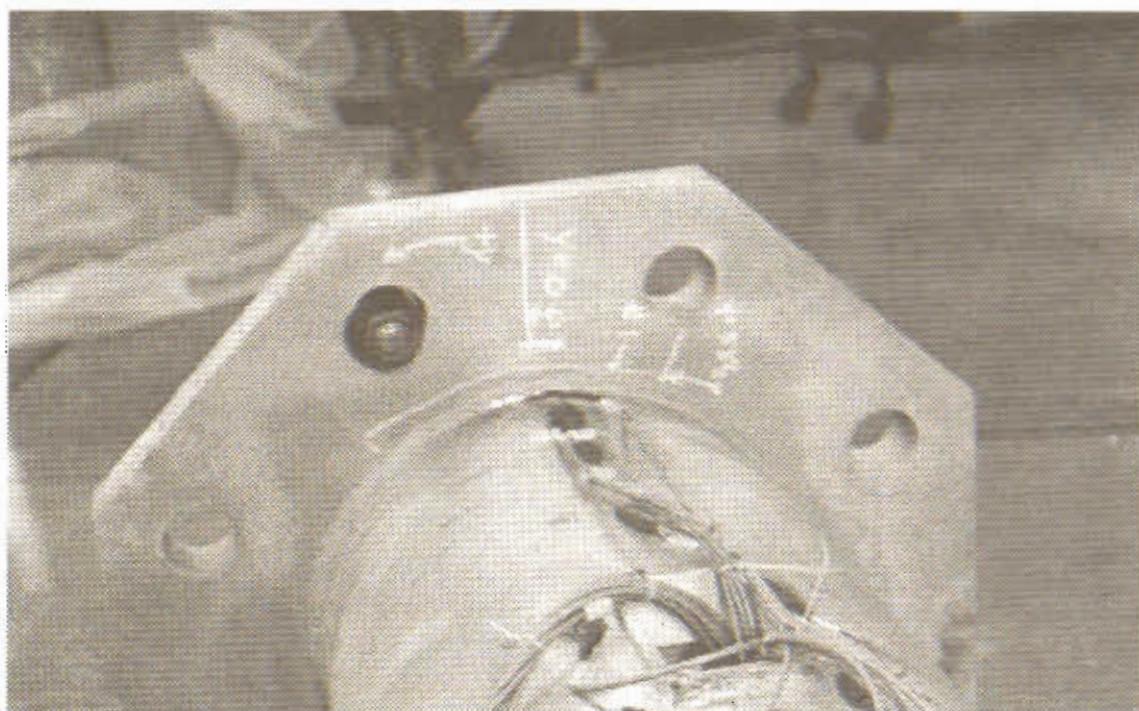
Figure 5.10: Location of flaws on the tension side of the post detected by ultrasonic testing

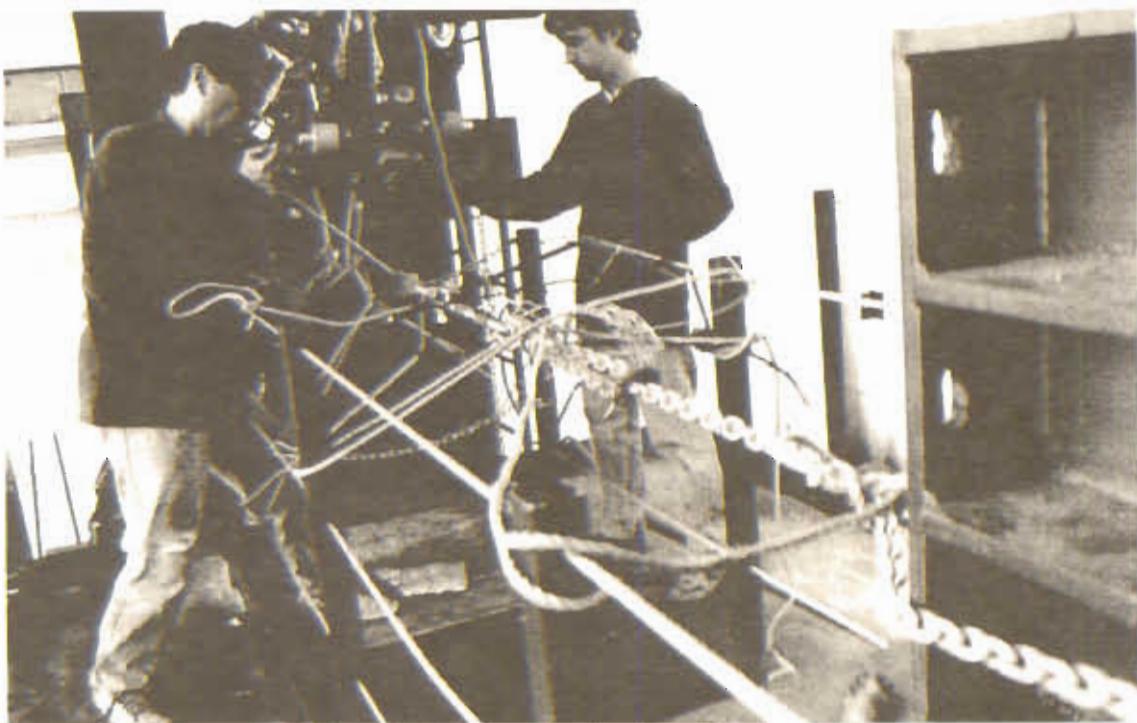
Figure 5.11: Test setup for the pull-back tests

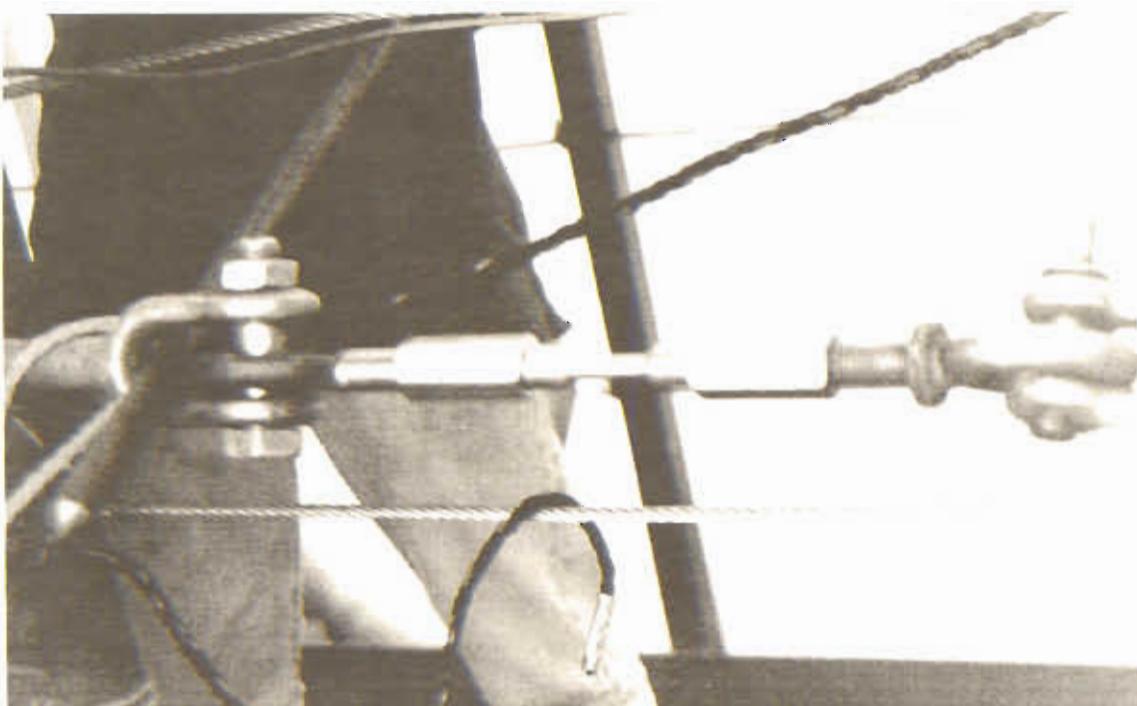
Figure 5.12: Machined bolt used for the sudden release of applied load
